GENERAL:

The structure is reinforced concrete railway bridge of arch form which is built about fifty year ago. Its free span length is 40 meters and its width is 4.6 meters. It was recently strengthened by the use of Carbon Fiber Composites. Strengthening was done without closing down the bridge from traffic.

Description of Historic Arch Railway Bridge Rehabilitation Project

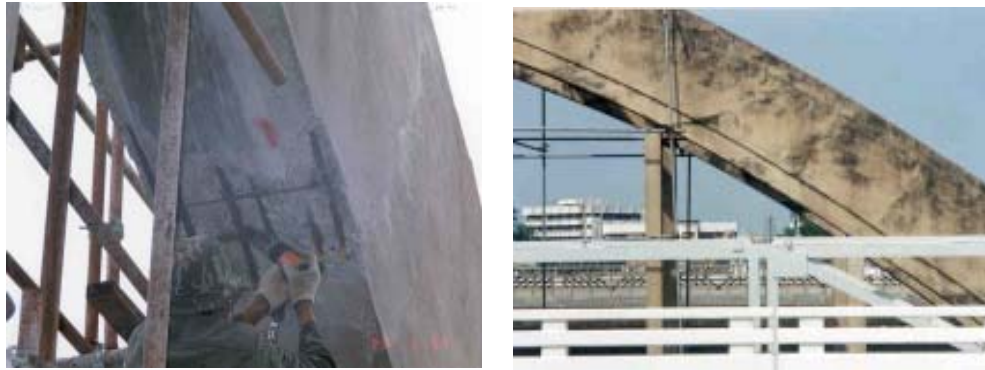
During the investigation reinforcing corrosion, concrete spalling and numerous cracks were found in the arches, hanger columns, beams and slabs. These conditions were determined to have been caused by the excessive loading that the bridge had to carry. The moisture in the air and concrete carbonation had also contributed to the weakening of the structure.

1. Reinforcing steel corrosion and the numerous cracks that were found on the arches, beams, hanger columns and underneath the slab.

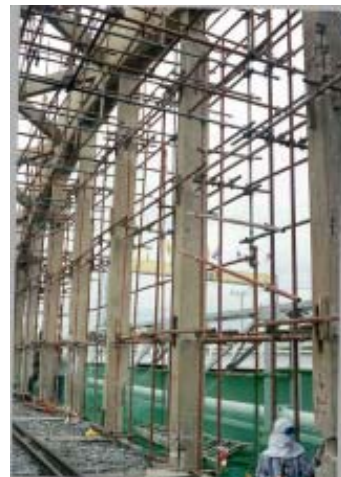
Scaffolding was set up on both sides of the bridge. A movable platform was installed underneath the bridge under difficult circumstances with limited space between the bottom of bridge and the top of the barges that passed by.

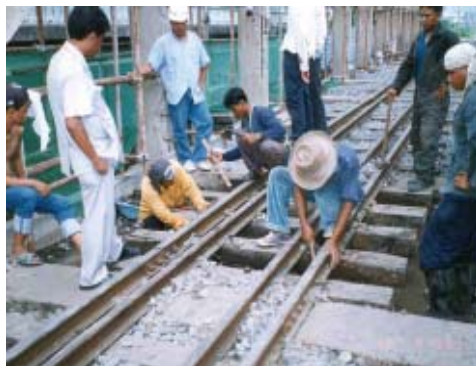
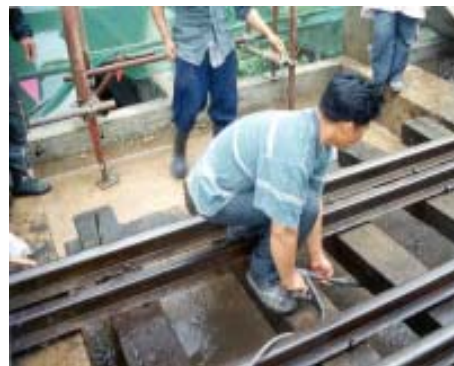
1. Heavy rainfall continued for many weeks while the project was on its way. This made surface preparation and other works more difficult. All surfaces must wait until dry up before installation of fiber sheet.
2. Crushed rocks on top of slab had to be removed before repairing of slab. All rocks must be filled back as soon as possible after the work finished. Track had to be reset and leveled. All processes consumed a lot of time and were difficult because of freight trains, which will run by over the bridge every 30 to 90 minutes.
3. Oil stain spreaded through out many areas. This caused surface preparation work to be more difficult. When crushed rocks were removed out, more corrosion was found.
